TS-PIC- 94110
April 1994

Aerial Photographic Site Analysis Ventron/Velsicol Wood-Ridge, New Jersey

EPA Region 2
OERR

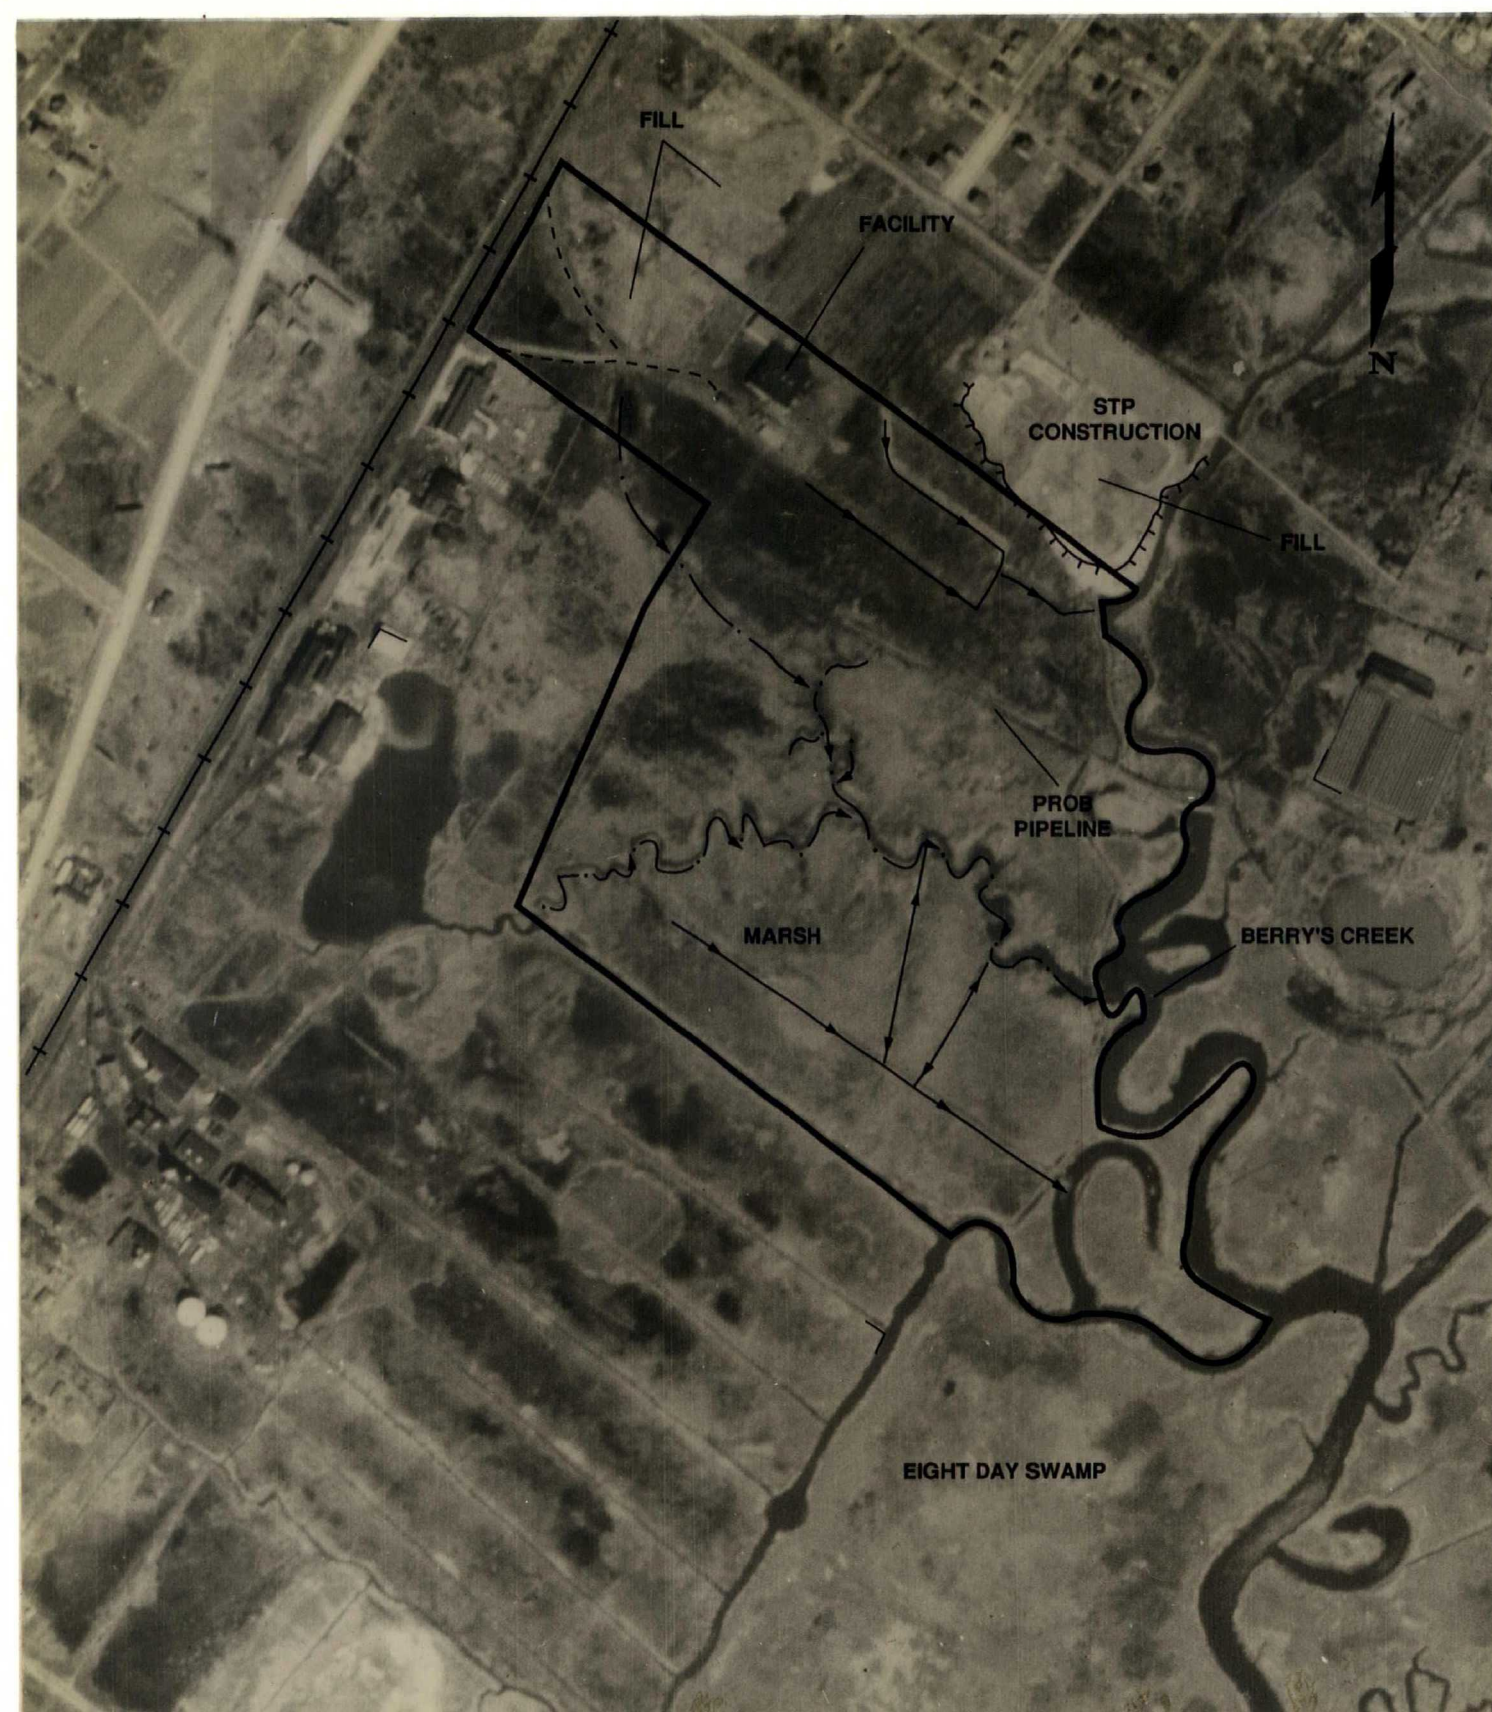
FIGURE 2
VENTRON / VELSICOL

The site is composed primarily of marshlands; the few industrial buildings (not annotated) of the facility were probably built on fill material. Medium-toned earthen material has been used to fill the area between the facility and the railroad. Lighter-toned earthen fill material is being used for construction of a sewage treatment plant (STP). No evidence of waste disposal was associated with these fill areas.

Site drainage is characterized by natural marsh drainage patterns and channelized drainage which flow to Berry's Creek and the Eight Day Swamp.

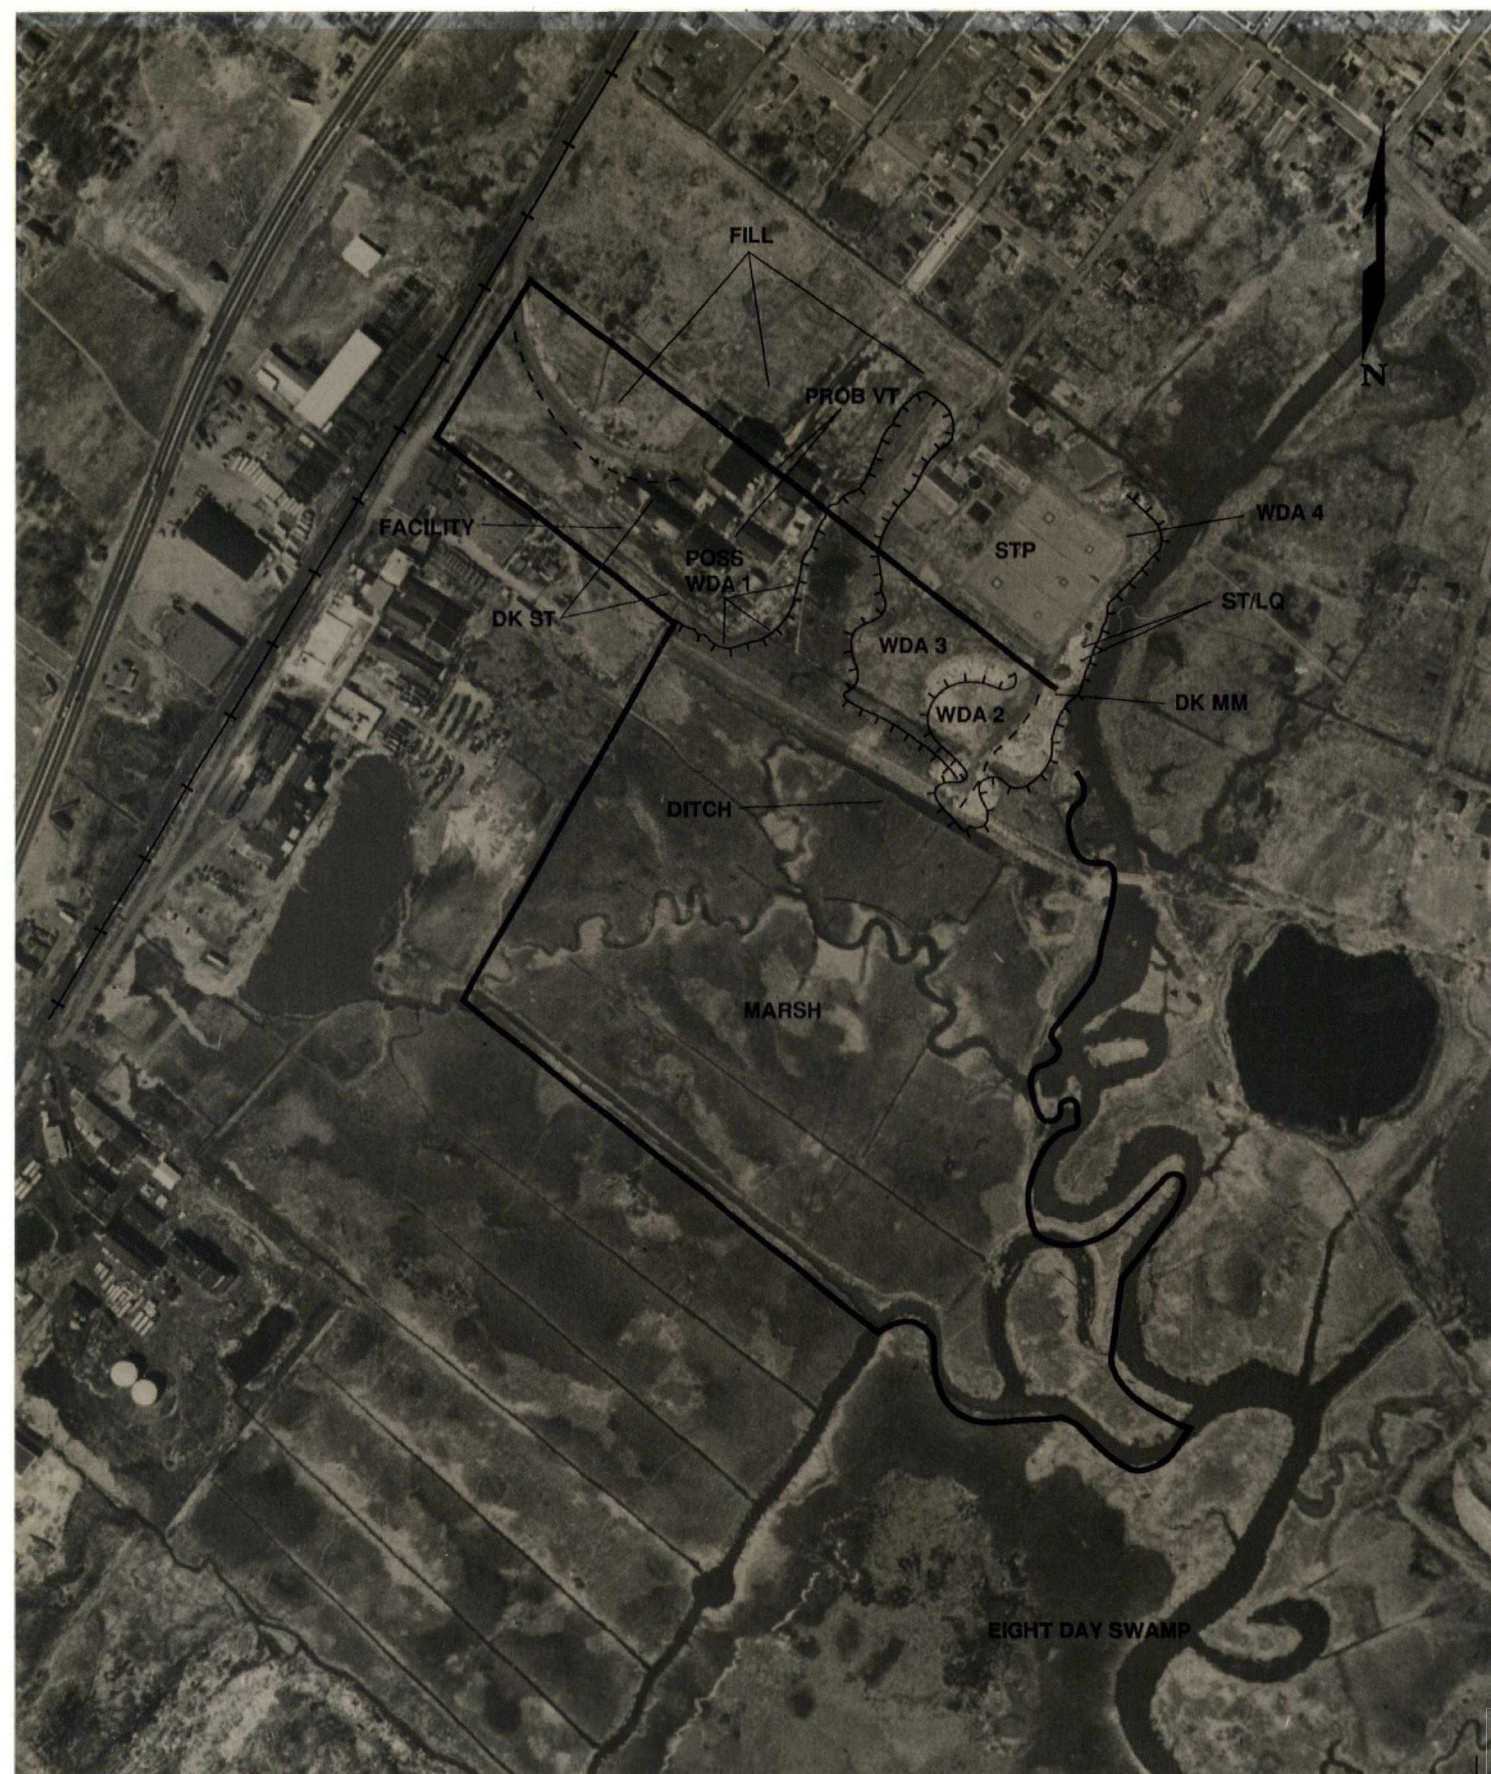
FIGURE 3
VENTRON / VELSICOL

Additional buildings (not annotated) have been constructed since 1940 and probable open storage of materials and equipment (neither annotated) can be seen at the facility. Light- and dark-toned materials make up the edge of the fill upon which the facility was built and indicate possible disposal activity (WDA1). Additional filling of medium-toned earthen material has occurred in the general area of the facility; however, no evidence of waste disposal can be seen in these fill areas.

Three waste disposal areas (WDA 2-4) appear associated with the sewage treatment plant. WDA2, an area of current disposal activity, is composed of light-toned materials. WDA3 is revegetated waste disposal area similar to WDA2. WDA4 is comprised of light- and dark-toned materials and possible stains or standing liquid (not annotated).

The large ditch in the center of the site is in the same location as the probable pipeline shown in 1940.

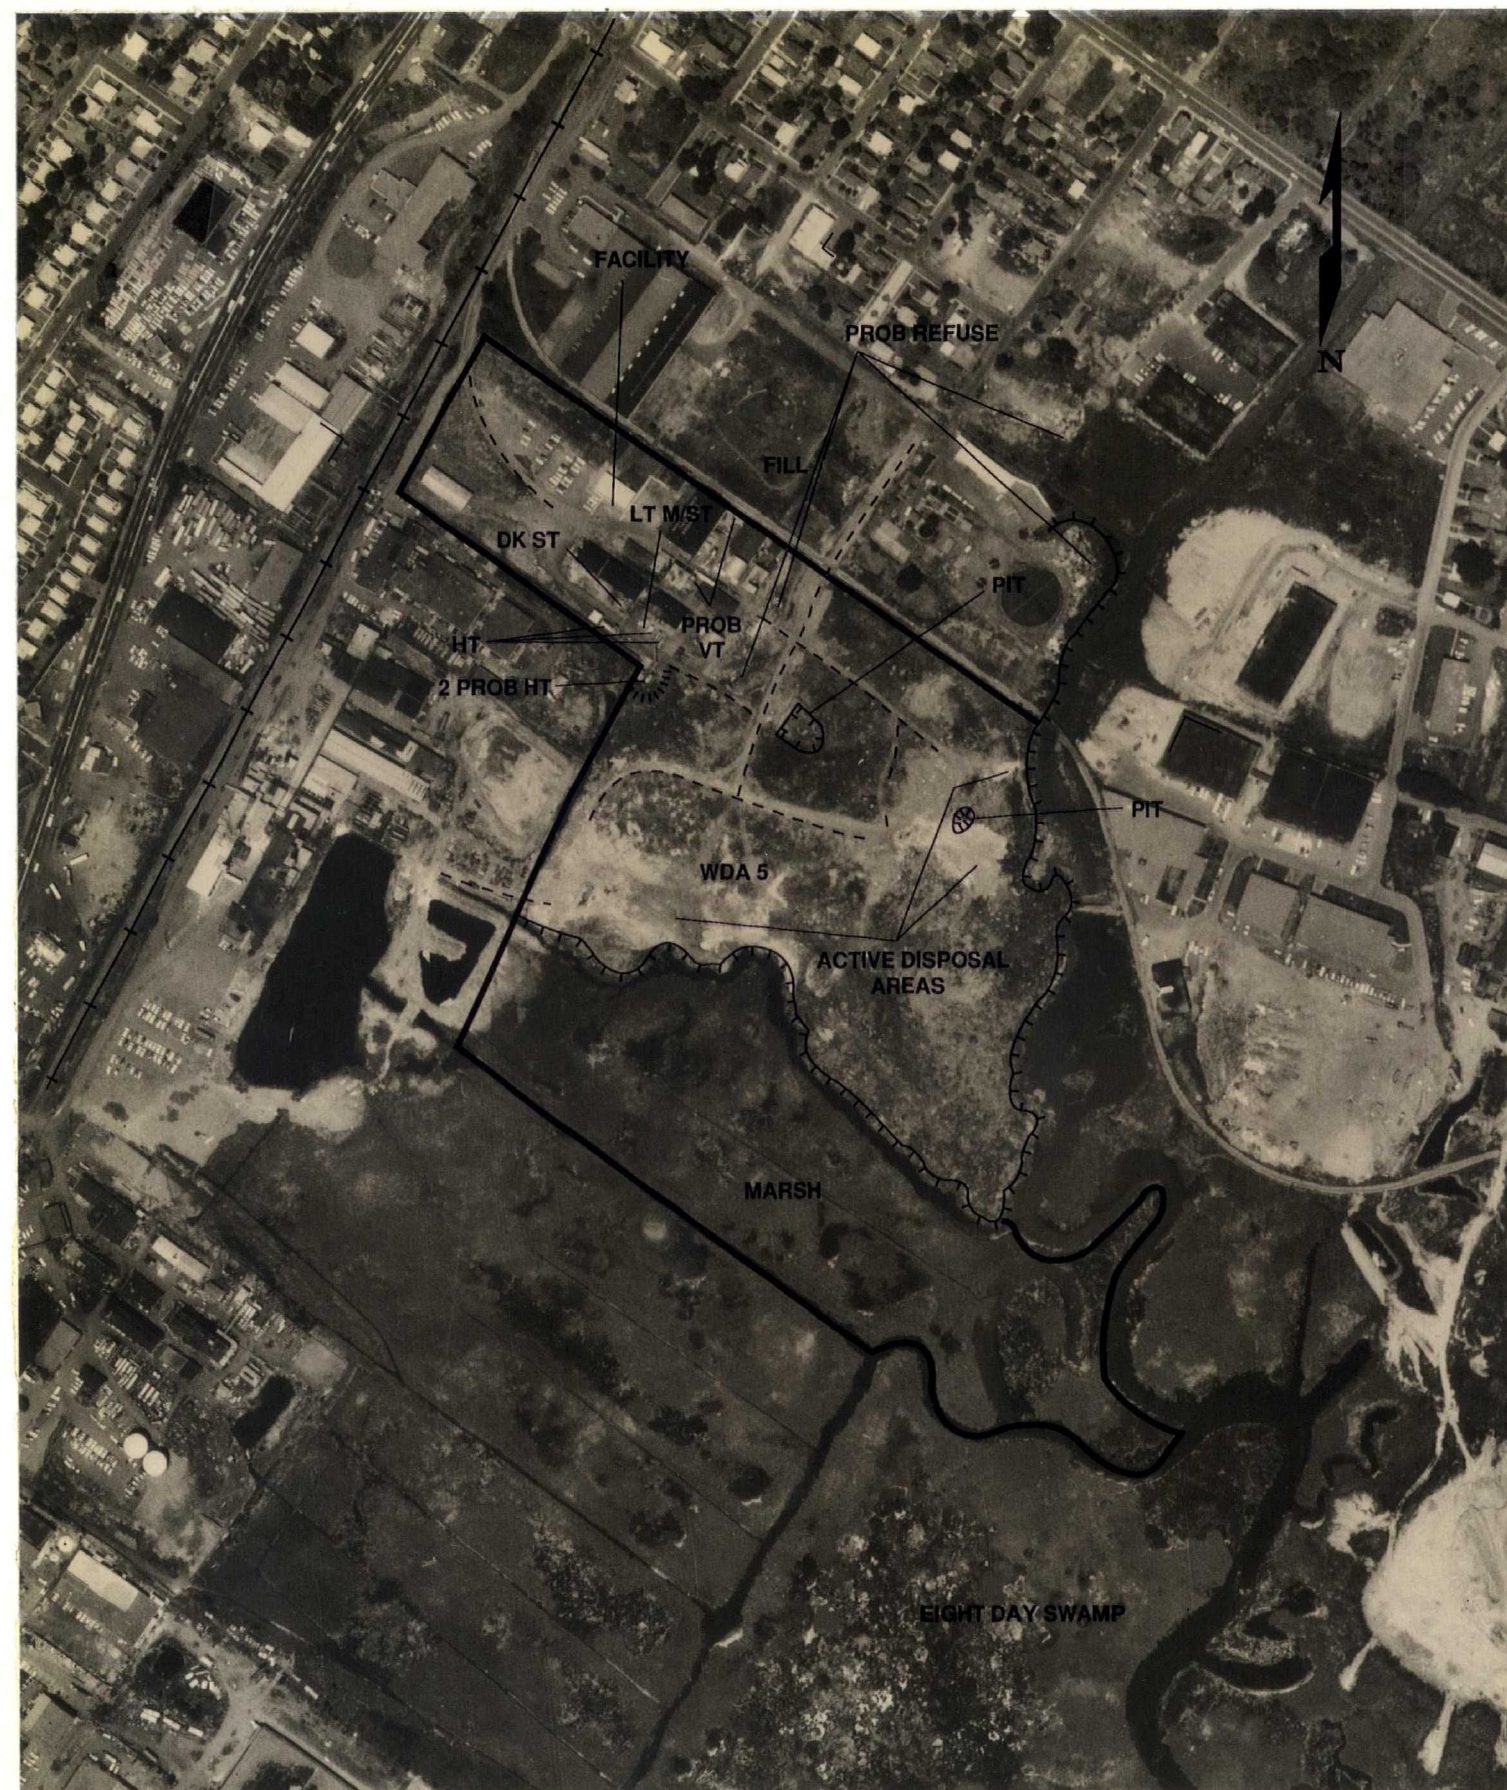
FIGURE 4
VENTRON / VELSICOL

Ownership of the facility is identified on top of the main building as Wood Ridge Chemical Corporation. Few new buildings (not annotated) have been added to the facility since 1951. Probable refuse lines the facility's boundary with the waste disposal area.

Waste disposal has occurred throughout much of the former marsh (WDA5). Active disposal areas are identified by ground scarring, probable dumpsters and access roads. Collateral information provided by Region 2 indicates that approximately 19 acres (8 hectares) of the site were utilized for disposal of wastes during this period. Access roads lead to the fill area from the facility, from the road next to the sewage treatment plant, and from an adjacent facility. A large pit adjacent to one of the access roads contains possible liquid. Another small pit contains light- and dark-toned materials.

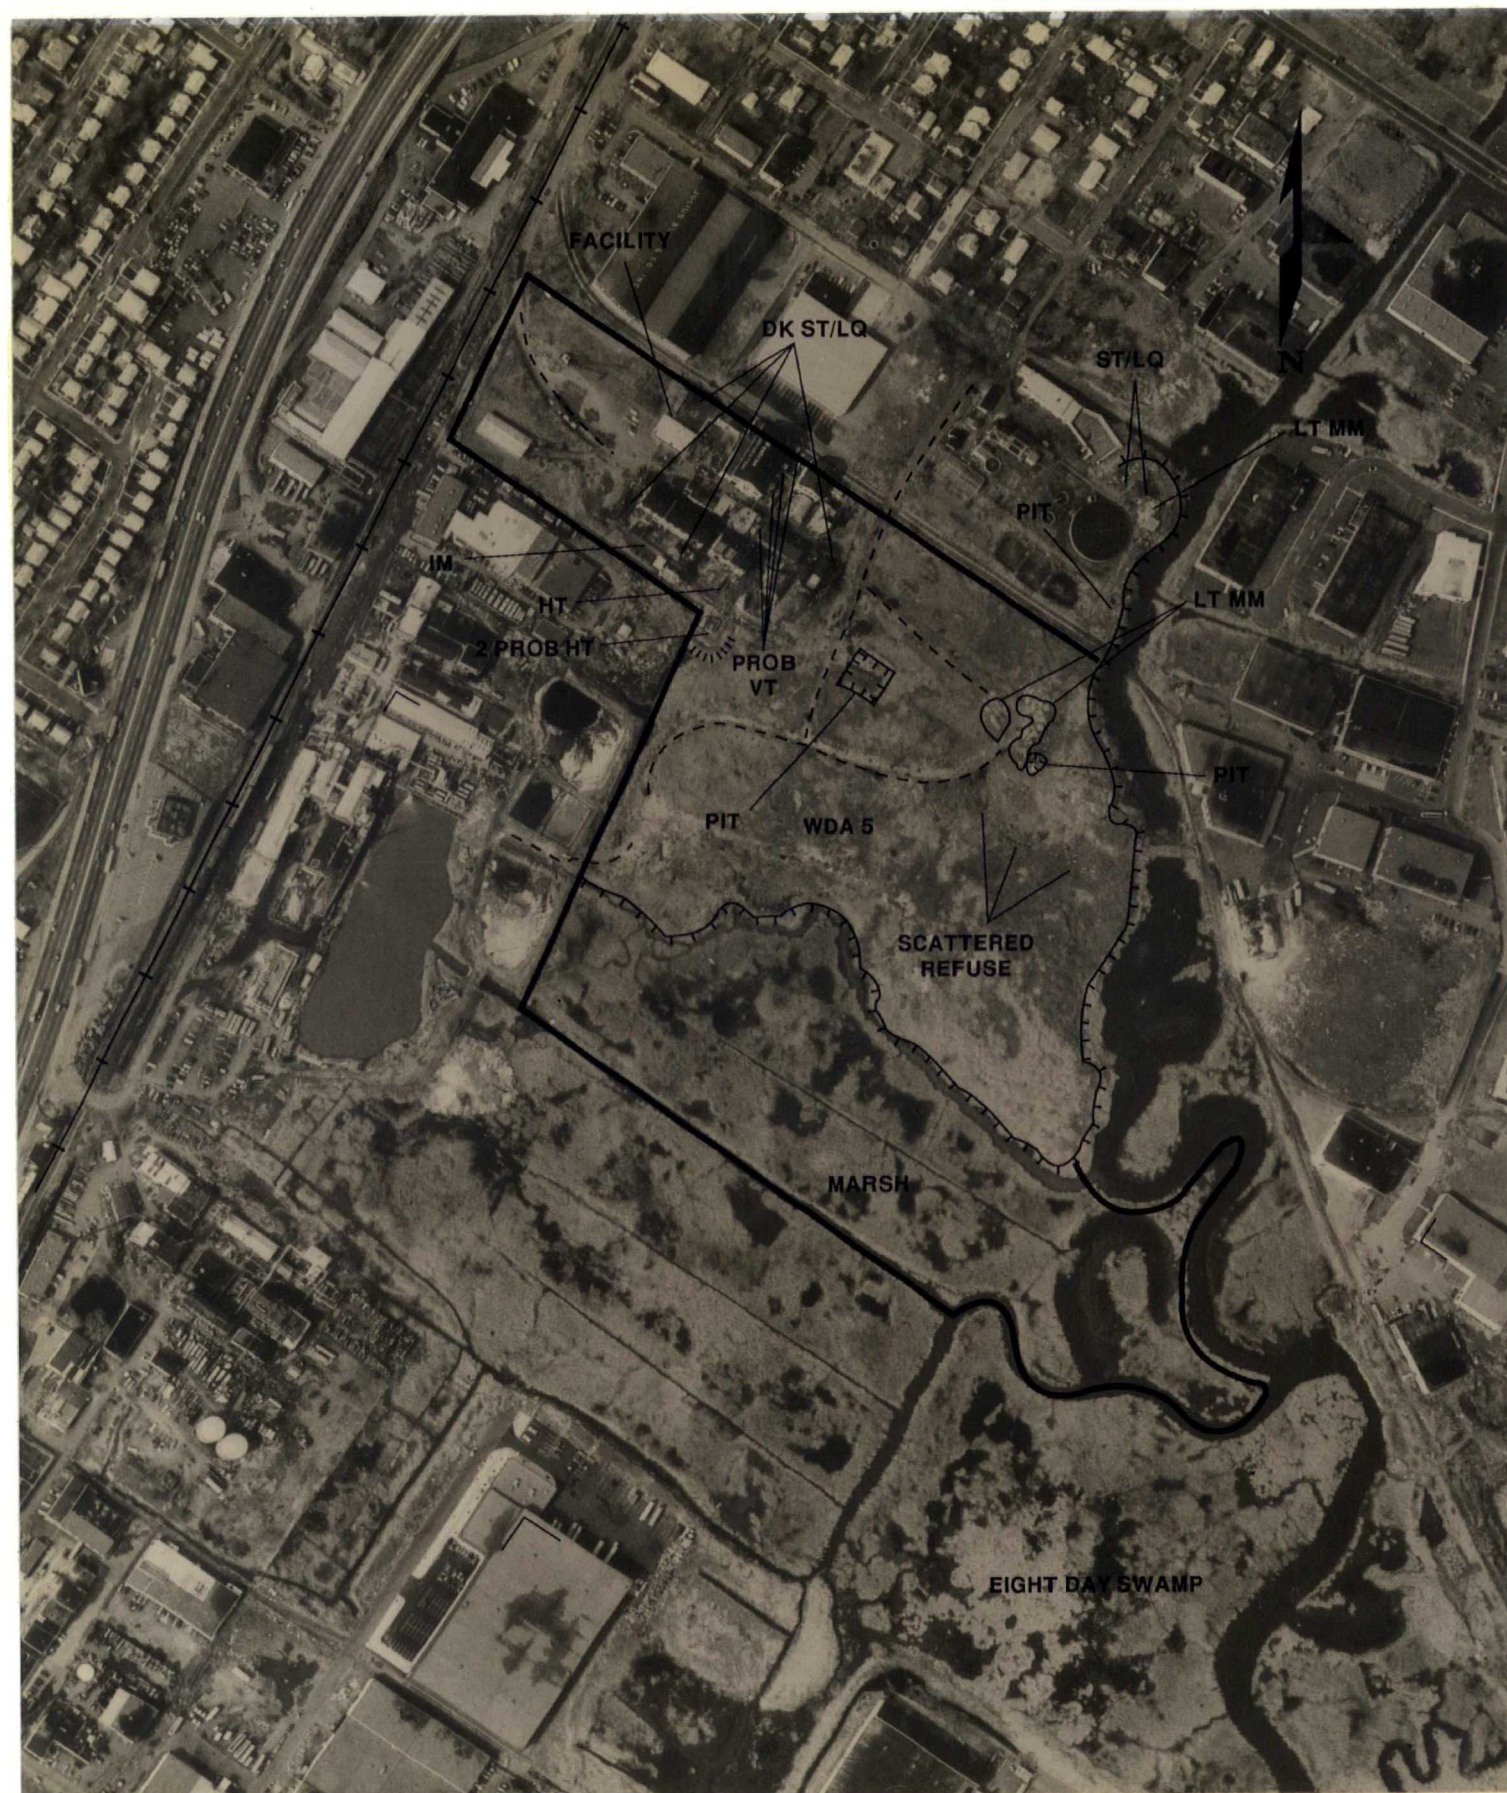
FIGURE 5
VENTRON / VELSICOL

Ownership of the facility is identified on top of the main building as Ventron Corporation. Open storage of materials and equipment (neither annotated) is occurring and dark-toned (DK) stains (ST) or standing liquid (LQ) are present, recent rainfall may account for these latter features. An empty impoundment (IM) is present, as are probable vertical (VT) and horizontal tanks (HT).

Waste disposal has not covered any additional marshland since 1966. Disposal activity is indicated by the presence of light-toned (LT) mounded materials (MM) near the small pit (first visible in 1966) and scattered refuse across the surface of the fill. The larger pit identified in 1966 has been partially filled. The remainder contains liquid, and is surrounded by a fence or berm.

The primary access road to the fill area is the road adjacent to the sewage treatment plant. There is no direct access road to the fill area from the facility at this time.
